TECHNICAL REPORT CERC-83-4

EFFECTS OF DOLOS BREAKAGE ON THE STABILITY OF RUBBLE-MOUND BREAKWATER TRUNKS SUBJECTED TO BREAKING AND NONBREAKING WAVES WITH NO OVERTOPPING

Dennis G. Markle, D. Donald Davidson

Coastal Engineering Research Center
U. S. Army Engineer Waterways Experiment Station
P. O. Box 631, Vicksburg, Miss. 39180

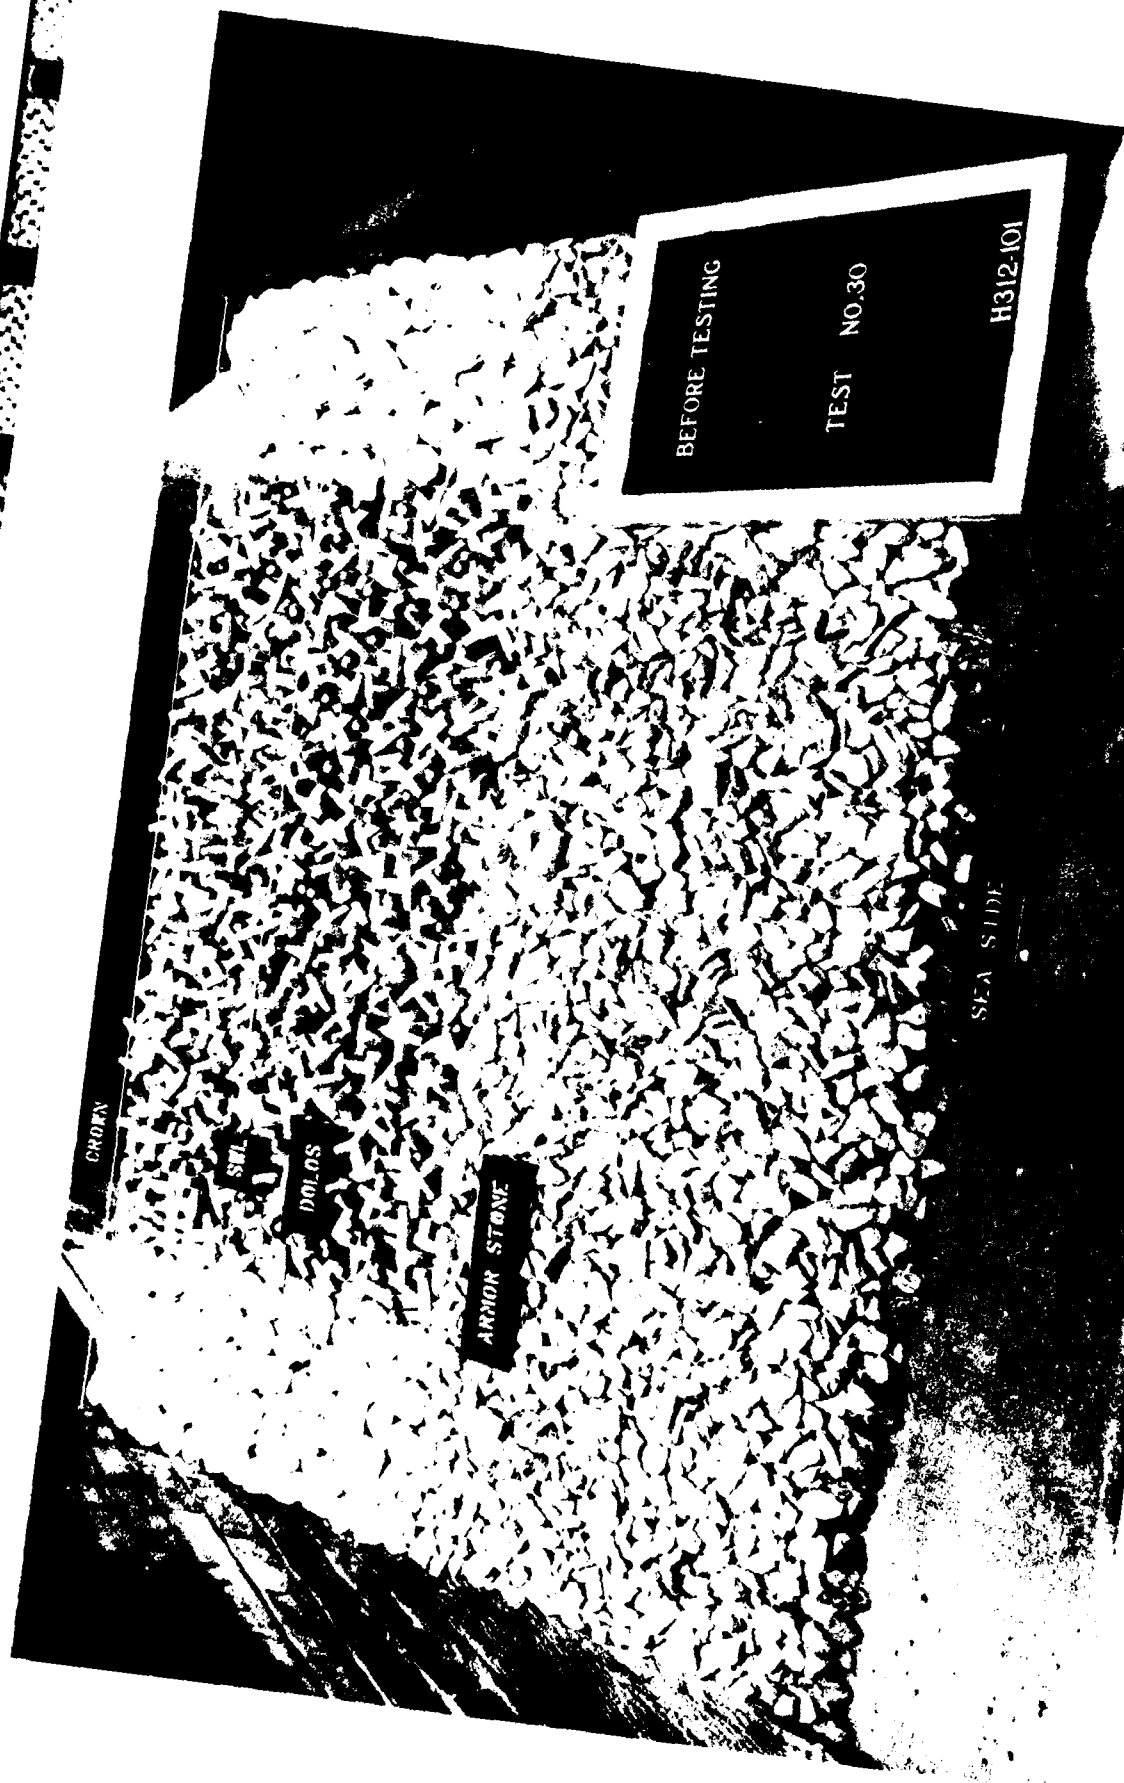
Photo 7. Before testing, 15 percent uniform breakage in bottom layer, nonbreaking waves

25. The 15 and 25 percent uniform breakage test sections were exposed to all of the nonbreaking wave test conditions. The 1.31- and 2.65-sec test waves produced acceptable degrees of damage on both the 15 and 25 percent breakage test sections (minor to moderate damage). The 1.89-sec nonbreaking waves produced acceptable damage (minor to moderate) on the 15 percent breakage sections and unacceptable damage (major) on the 25 percent breakage sections. Photos 7 and 8 show typical before-test conditions of 15 and

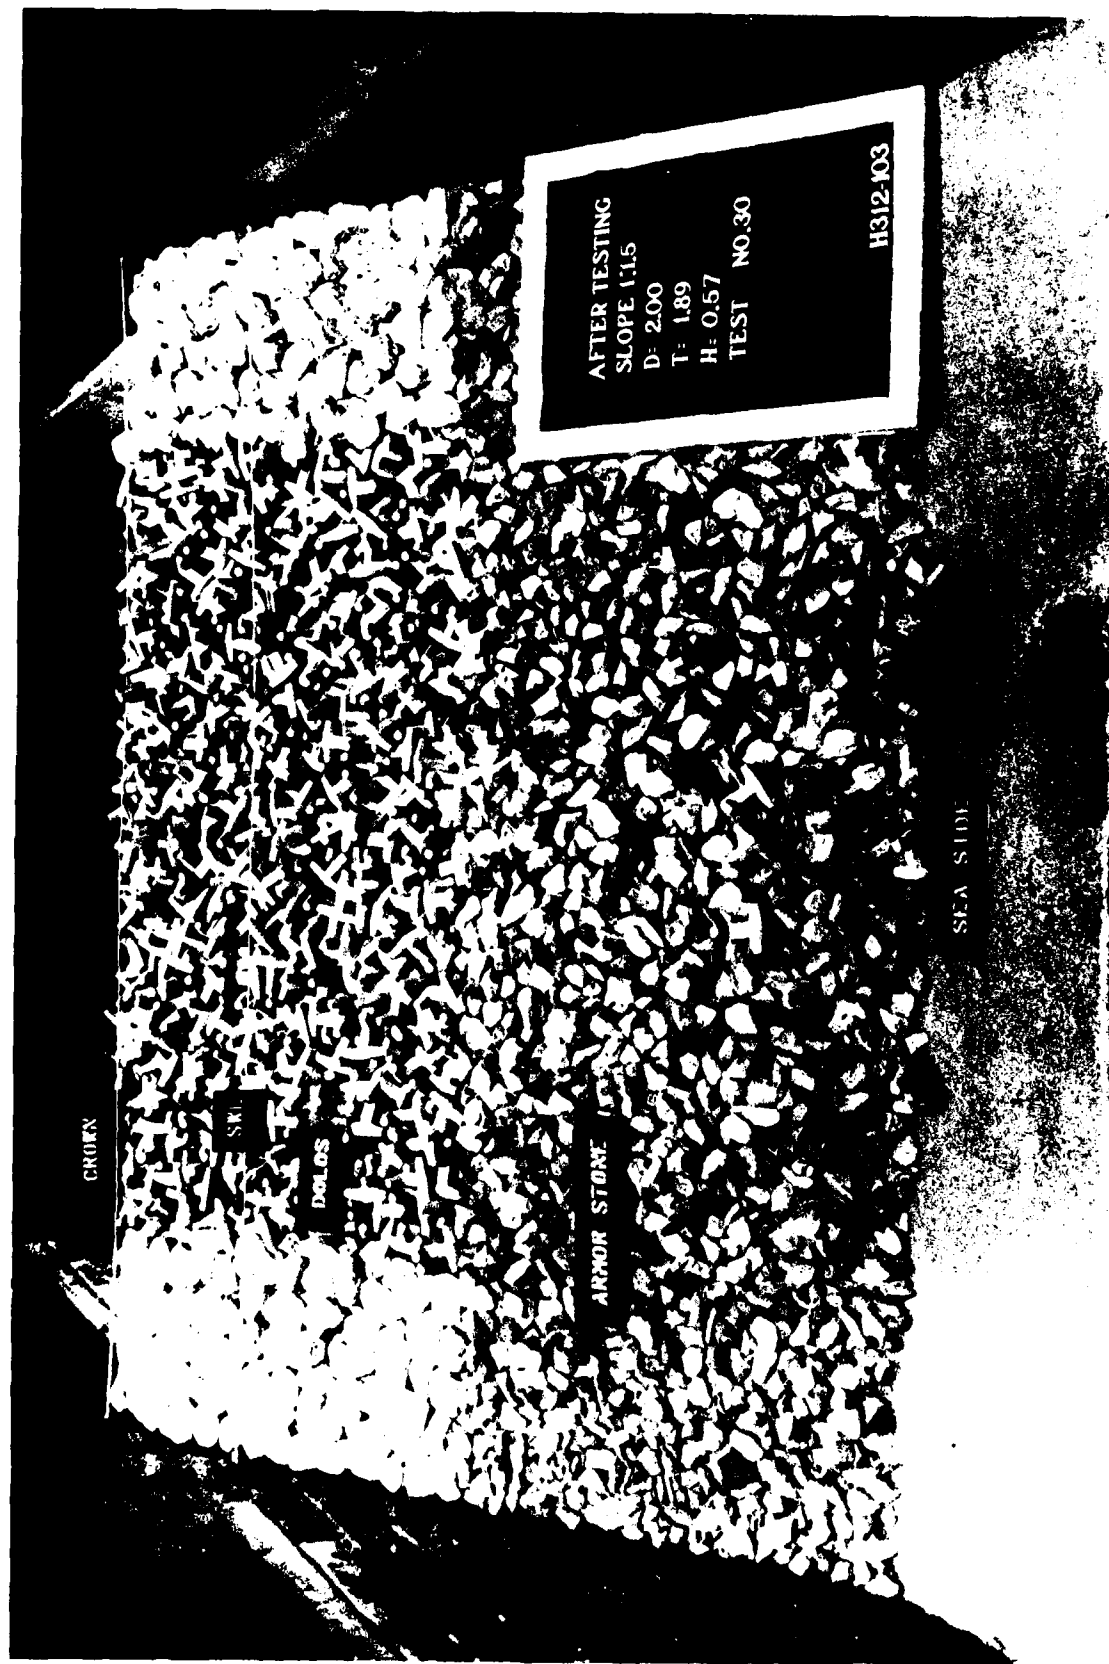
Photo 9. After testing, 15 percent uniform breakage in bottom layer, nonbreaking waves

25 percent breakage test sections, respectively. A typical view of the acceptable damage accrued on the 15 percent breakage test section is shown in Photo 9. Photo 10 shows one example of the major damage accrued by the 25 percent breakage test section when exposed to the 1.89-sec nonbreaking waves. As well as the displacement evident in the after-test photographs, the test sections with acceptable levels of damage had minor amounts of in-place rocking and reorientation of whole dolosse, while those test sections which sustained unacceptable degrees of displacement also exhibited in-place rocking and reorientation of armor units that ranged from moderate to major (Table 2).

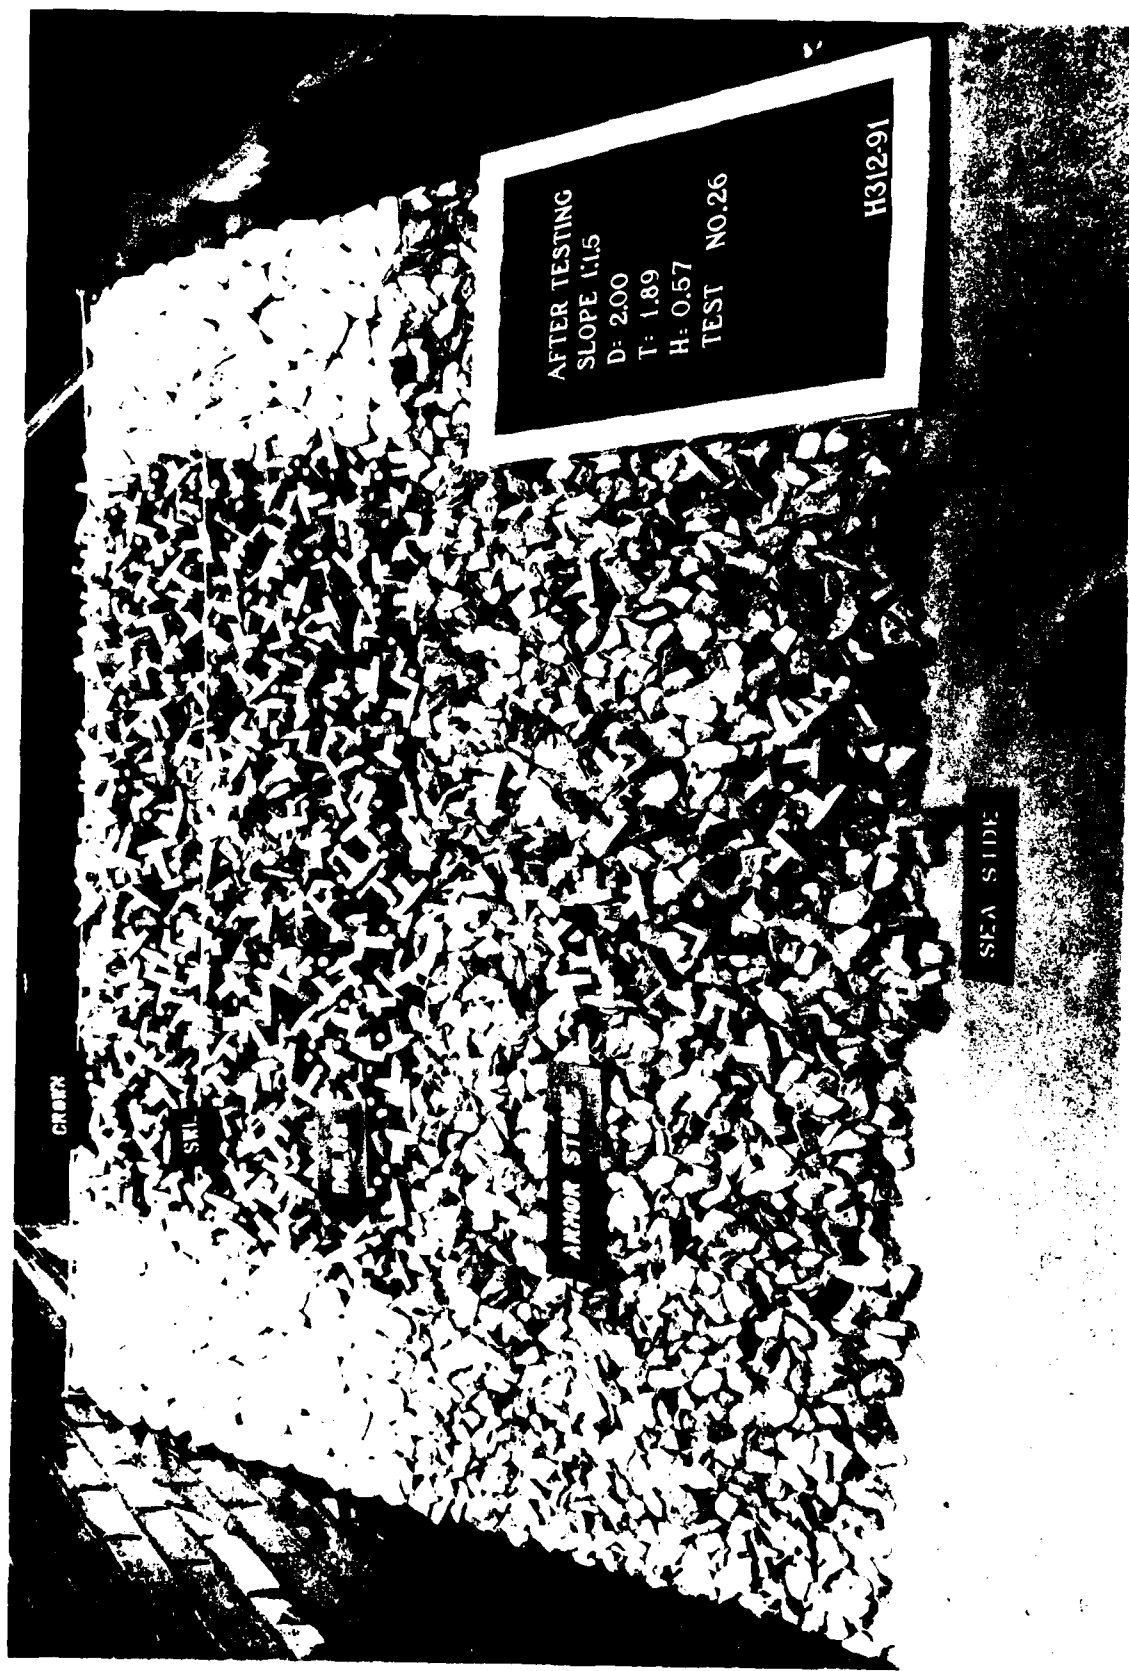
Photo 10. After testing, 25 percent uniform breakage in bottom layer, nonbreaking waves

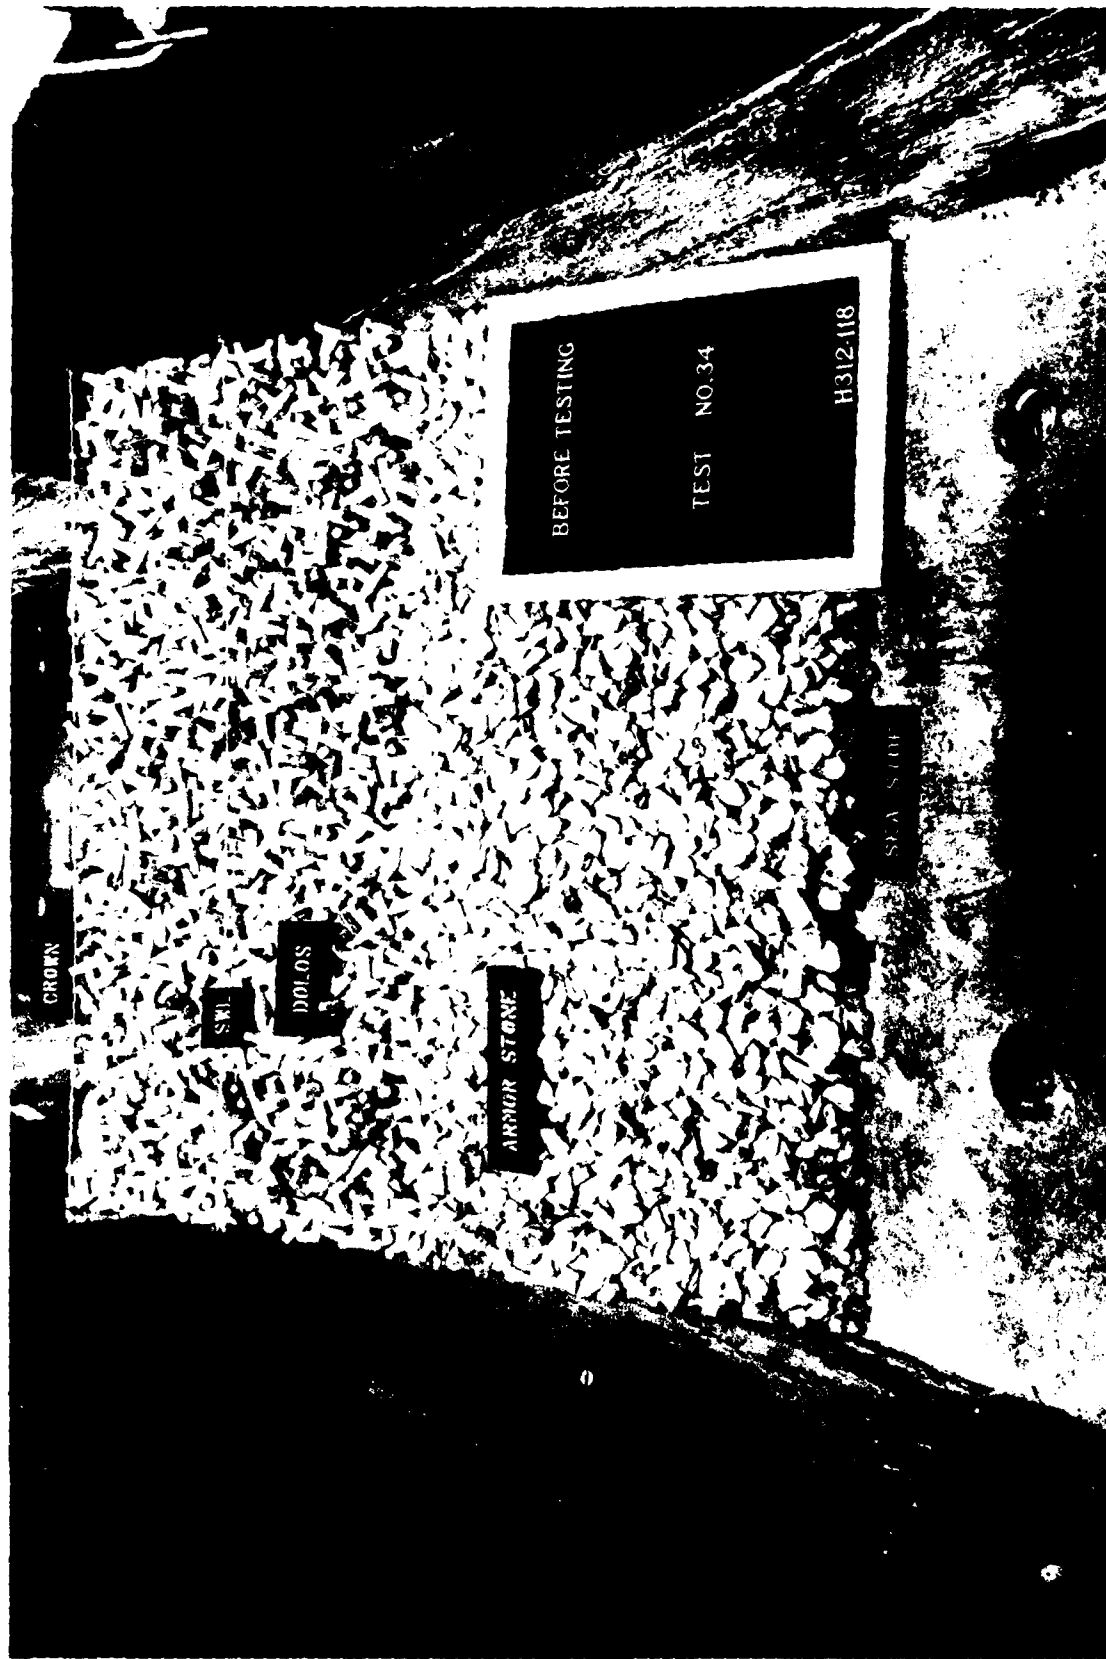
Photo 11. Before testing, 7.5 percent uniform breakage in both layers, nonbreaking waves

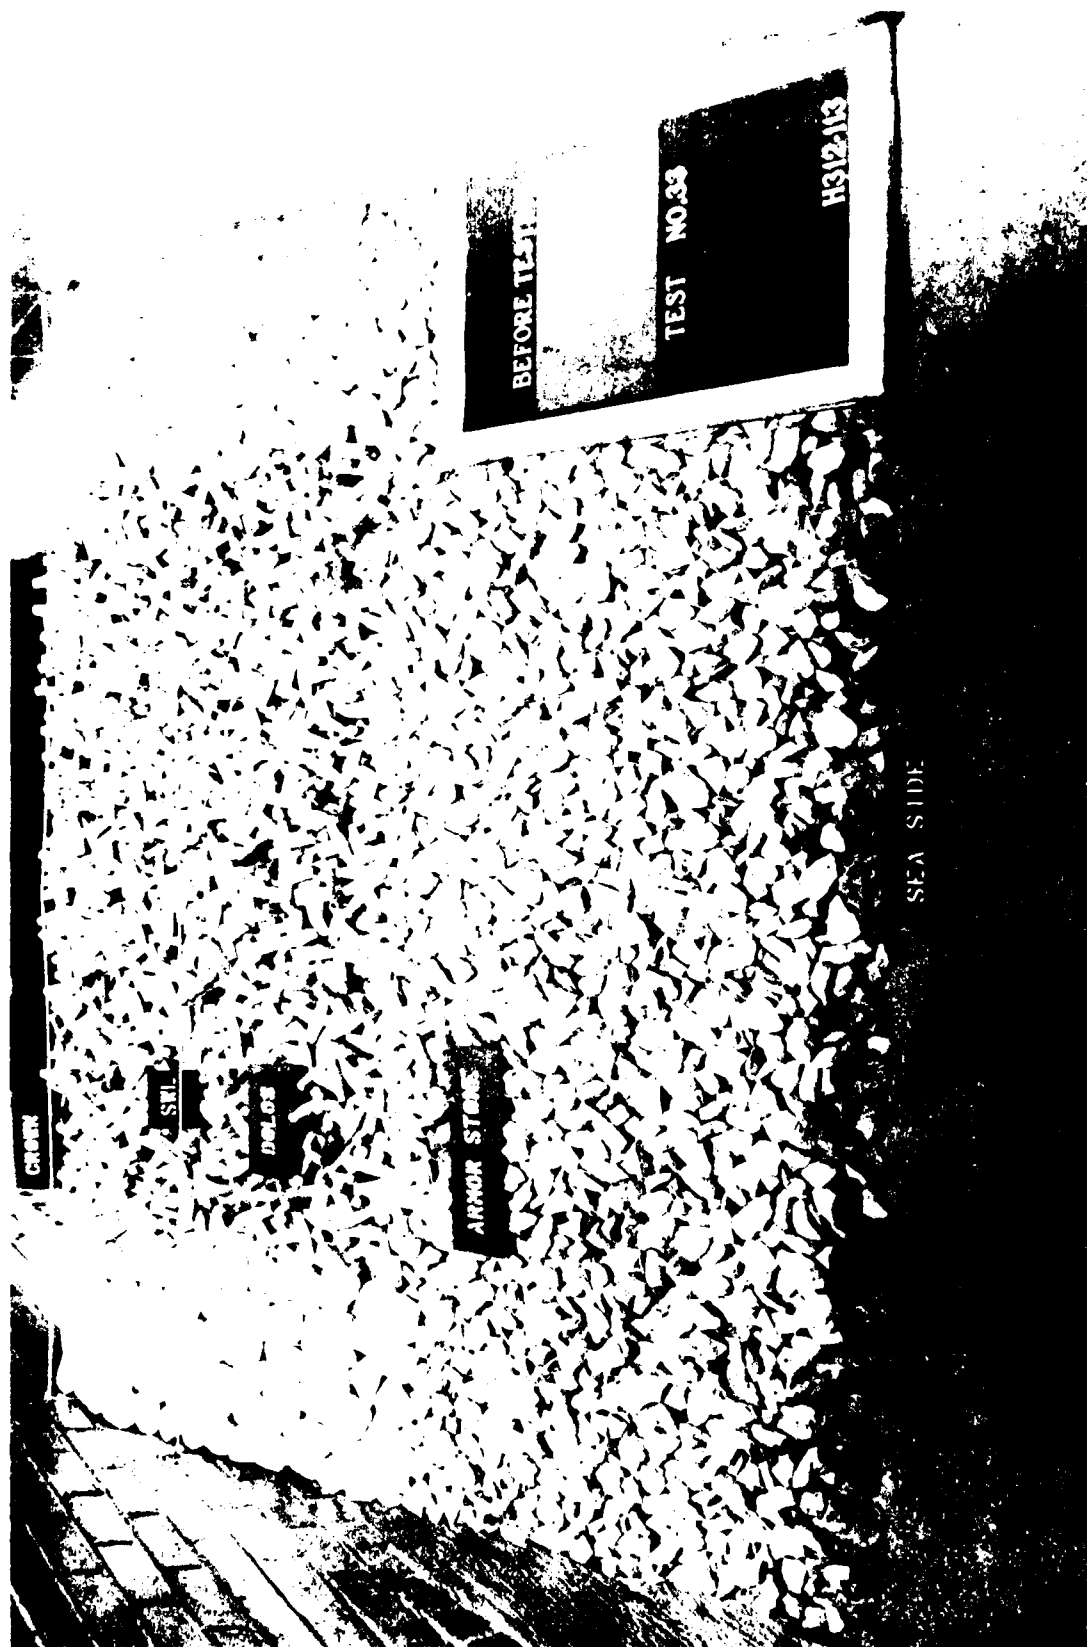
Photo 12. Before testing, 10 percent uniform breakage in both layers, nonbreaking waves

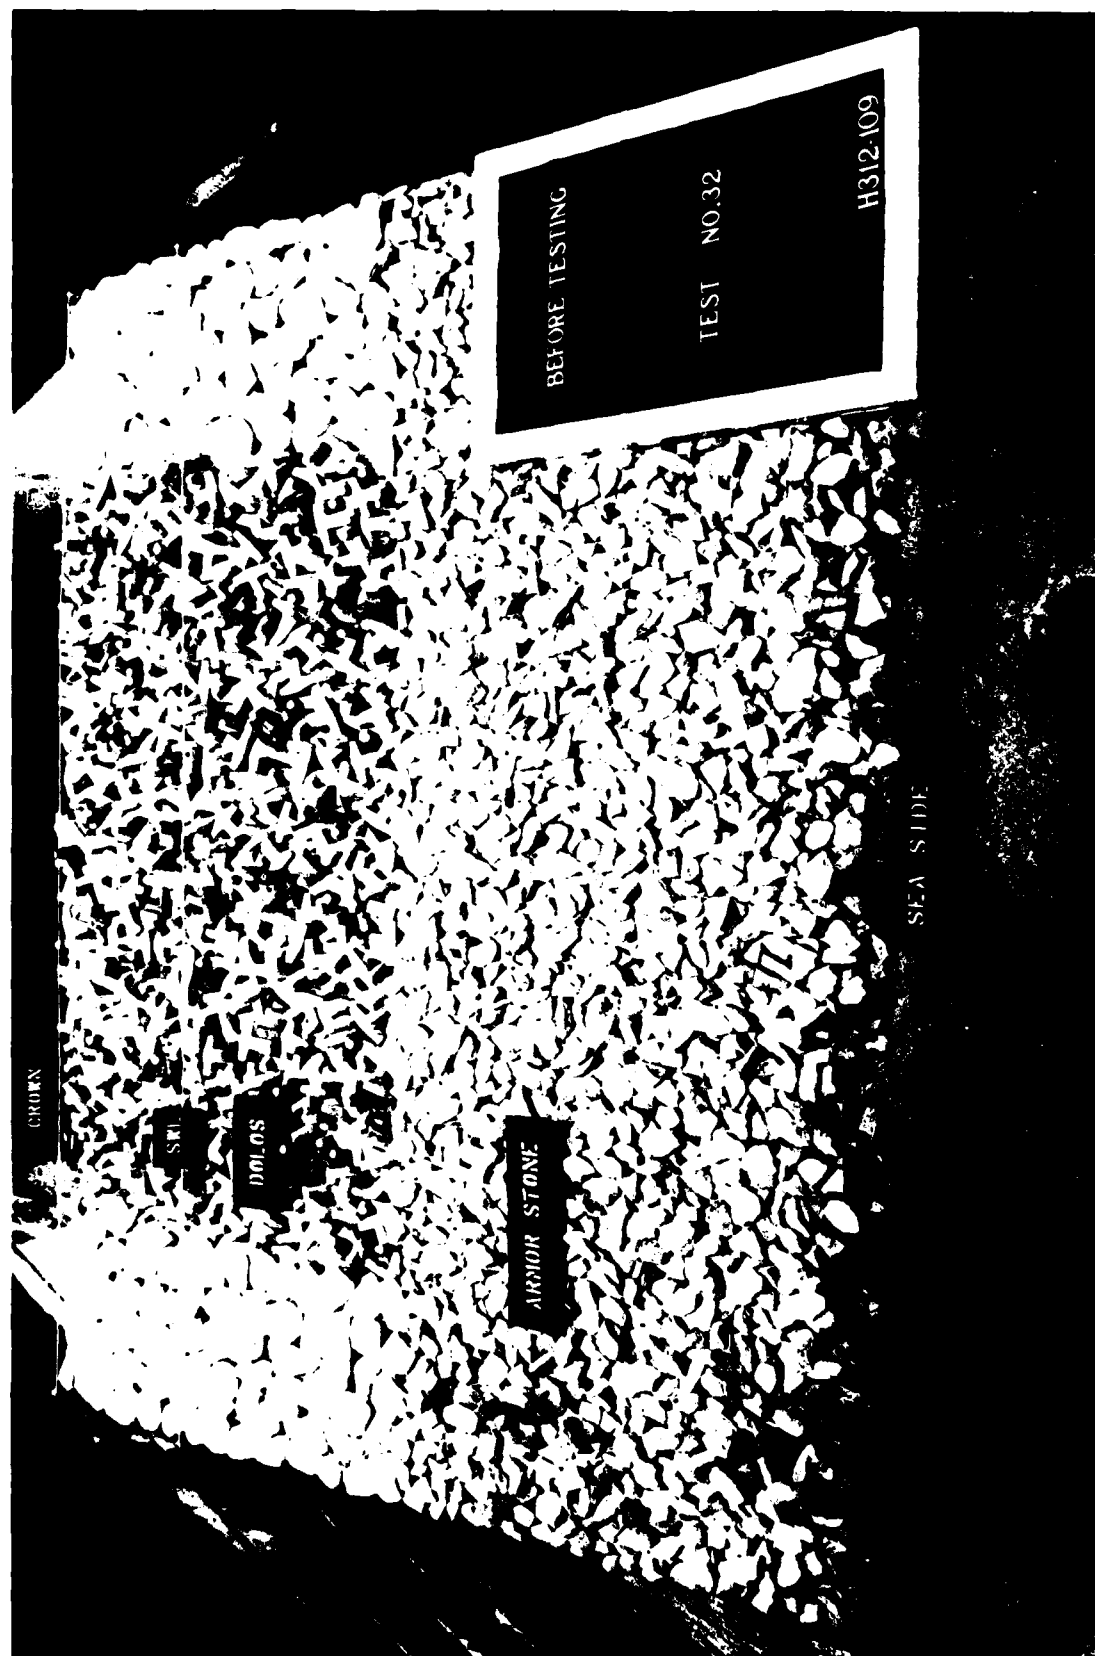
Photo 13. Before testing, 15 percent uniform breakage in both layers, nonbreaking waves

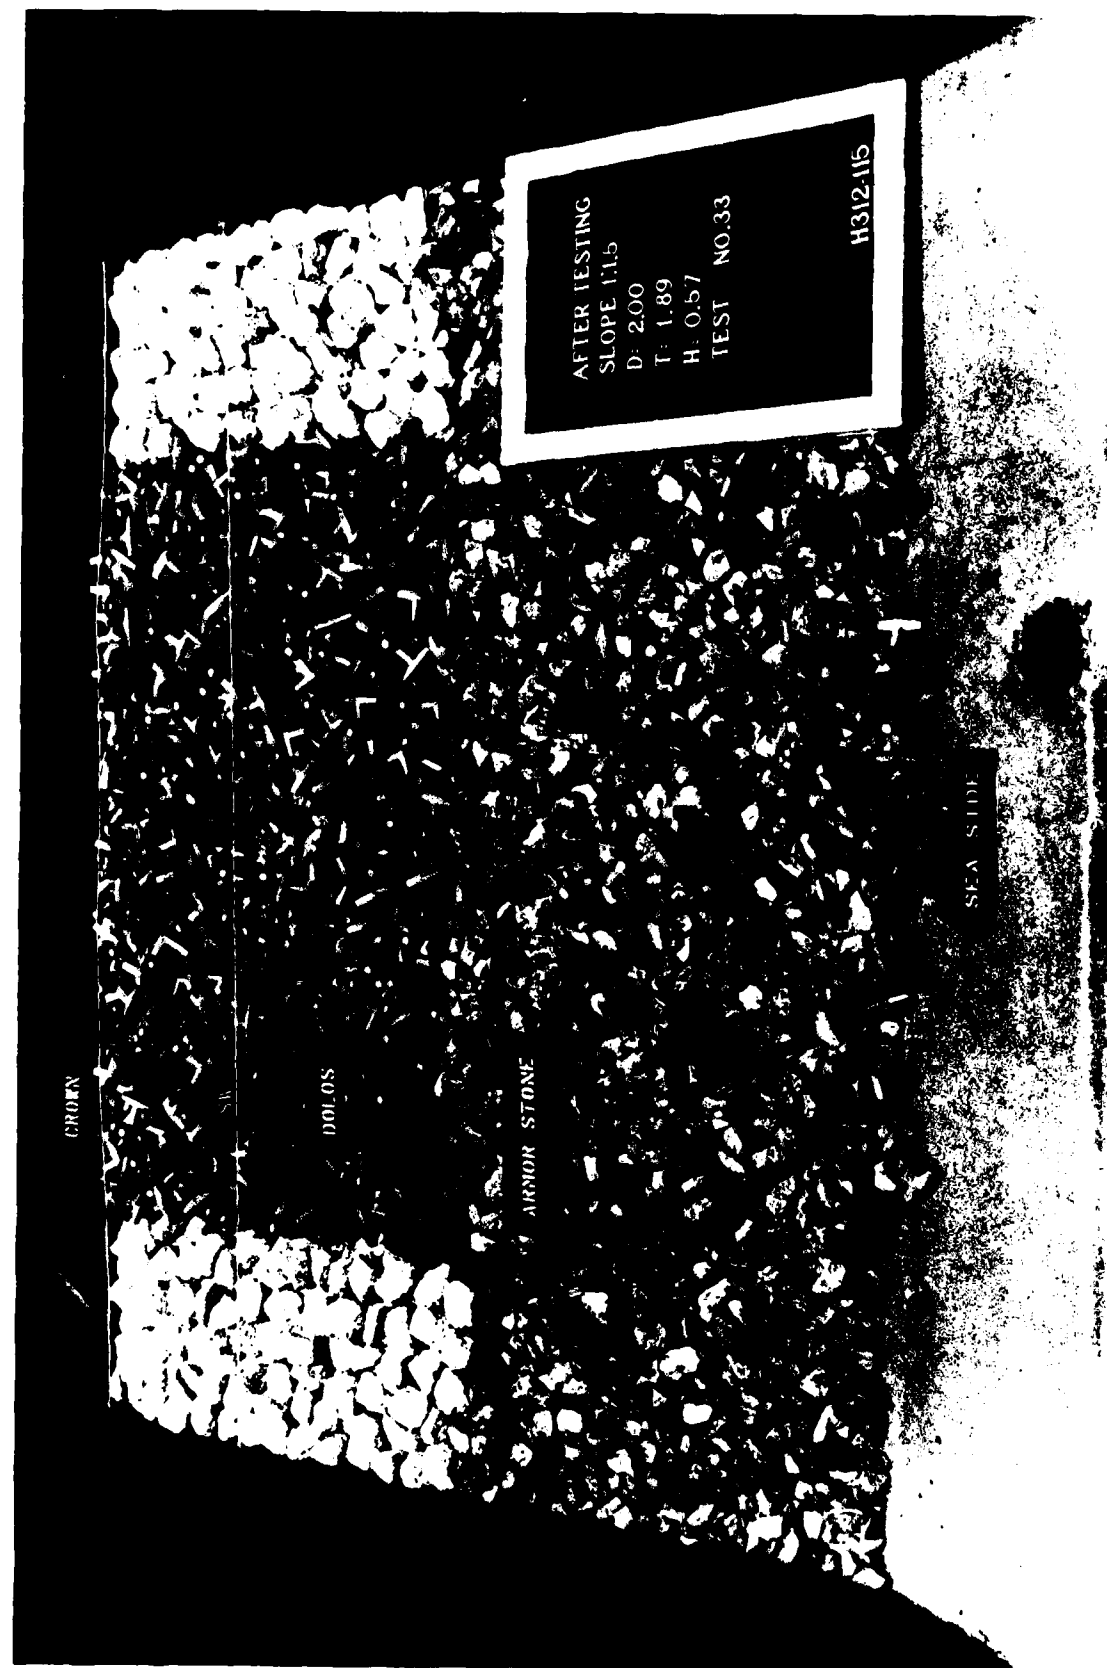
Photo 15. After testing, 10 percent uniform breakage in both layers, nonbreaking waves

breakage test sections, respectively. Photo 14 shows an after-test view of a 7.5 percent breakage test section. Photos 15 and 16 show typical after-test examples of the major damage sustained by the 10.0 and 15.0 percent breakage test sections (Table 2).

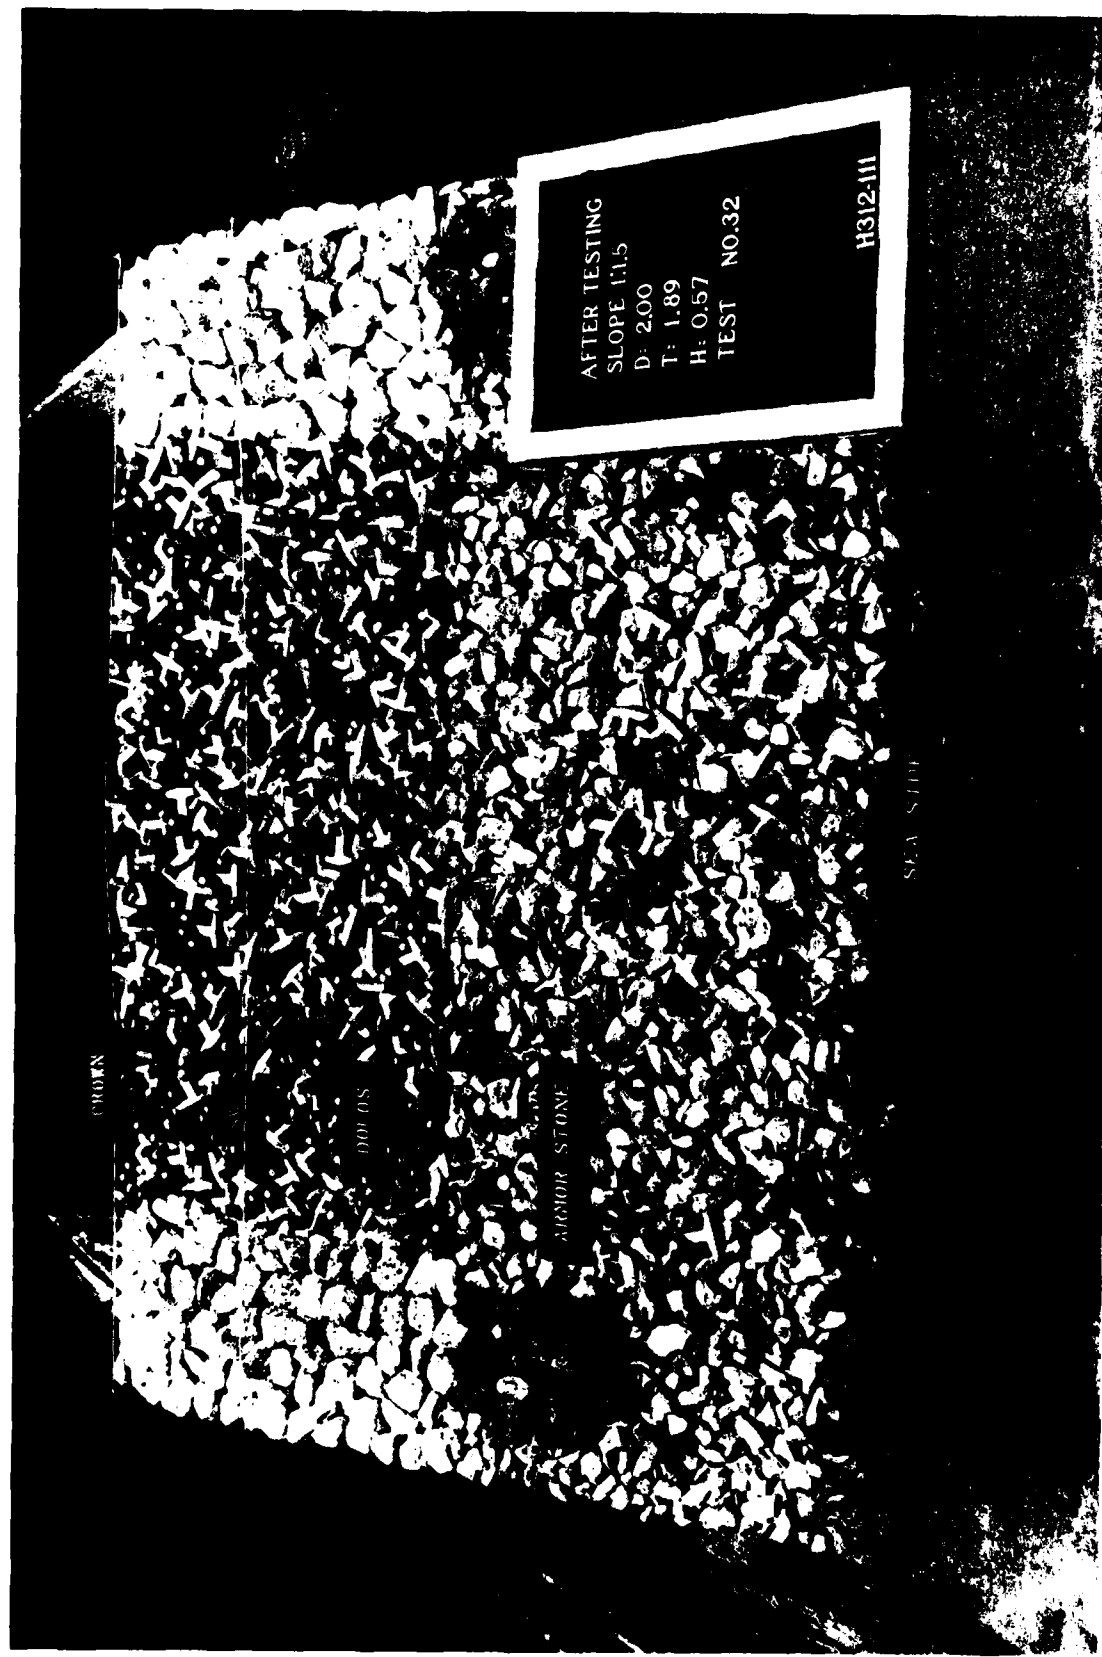
Photo 16. After testing, 15 percent uniform breakage in both layers, nonbreaking waves

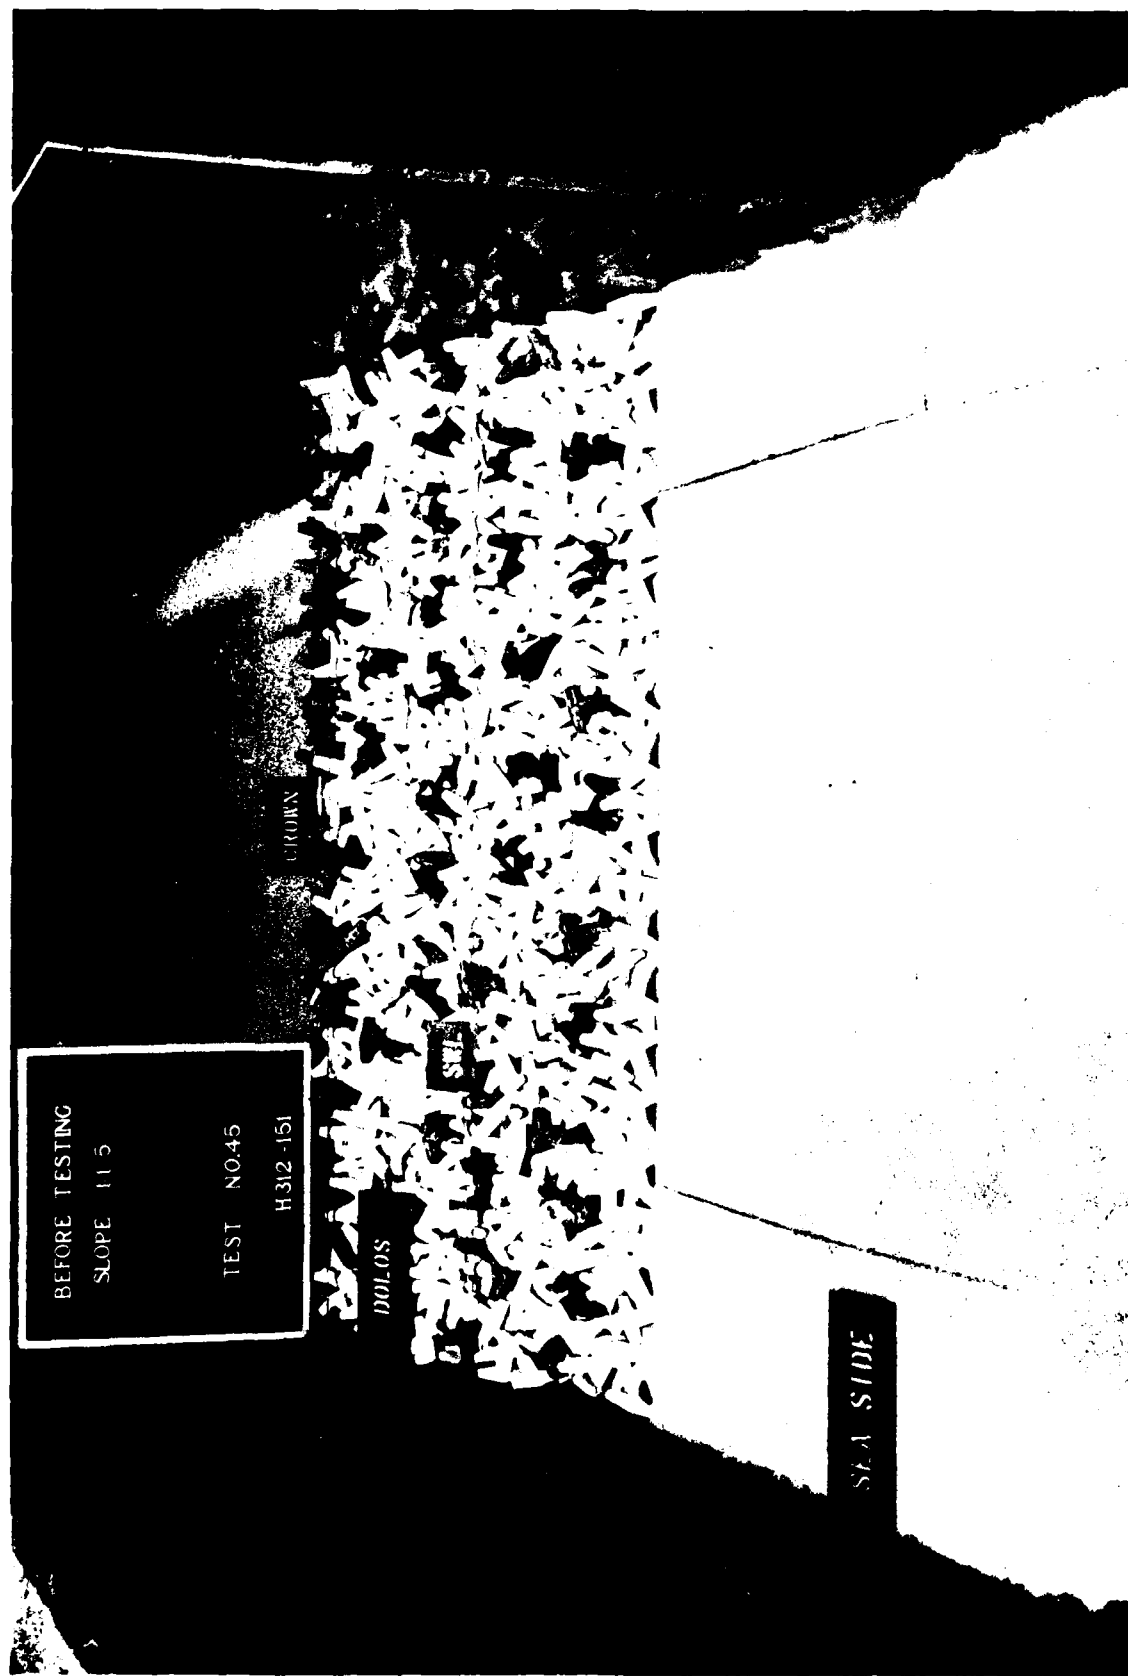
Photo 21. Before testing, 25 percent uniform breakage in top layer, breaking waves

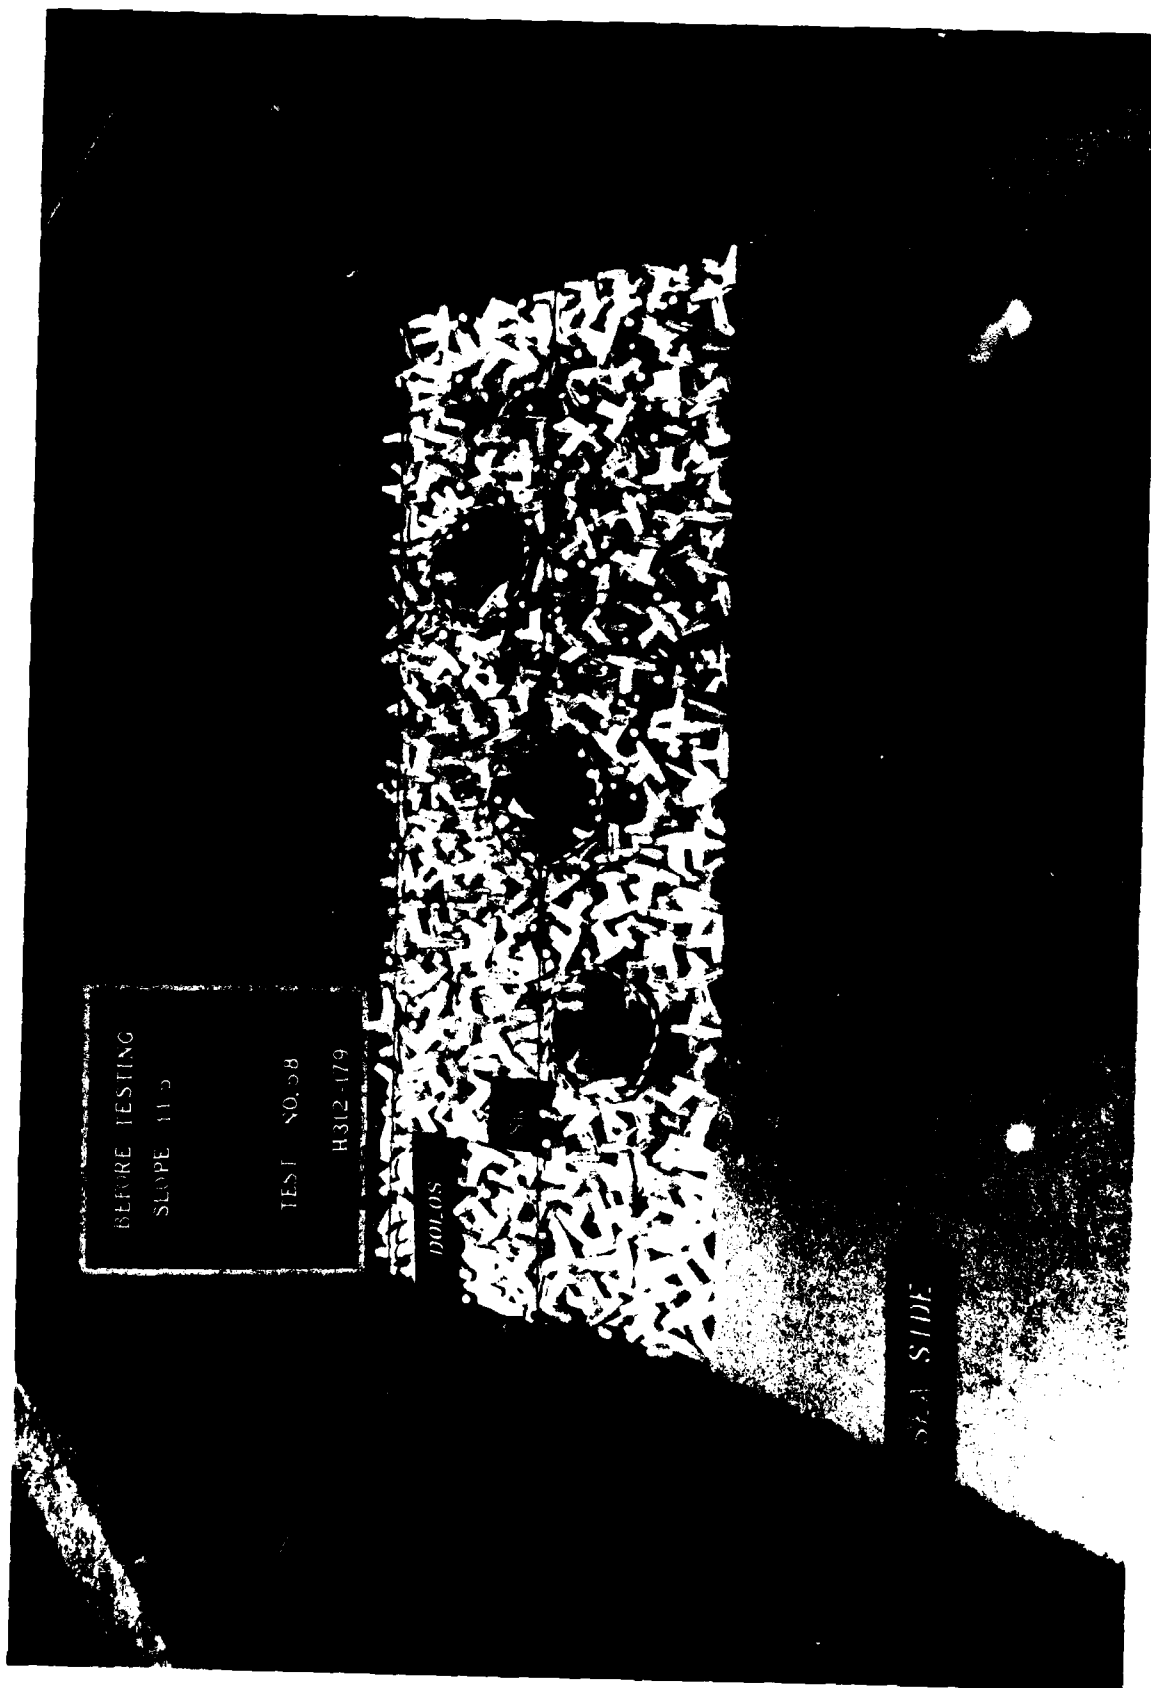
BEFORE TESTING
SLOPE 11.5

Photo 35. Before testing, 10-unit cluster breakage, breaking waves

33. The 10-unit cluster test sections (Photo 35) accrued moderate to significant damage during exposure to the breaking wave test conditions. The cluster located at the swl showed significant damage to both the cluster and surrounding whole dolosse. A large area on the upper side of this cluster had exposed underlayer, but this was covered when whole dolosse were displaced into the cluster. The remainder of the structure showed minor to moderate amounts of displacement, rocking in place, and reorientation of both whole and broken dolosse. The 5-unit cluster test sections (Photo 36) sustained minor to moderate damage when exposed to the 1.62-sec breaking wave conditions. The damage included minor amounts of both whole and broken armor unit displacement
